THE TORQUE•TUBE

THE NEWS PUBLICATION FOR MEMBERS

VOL.VII, NO.6 • APRIL 1989

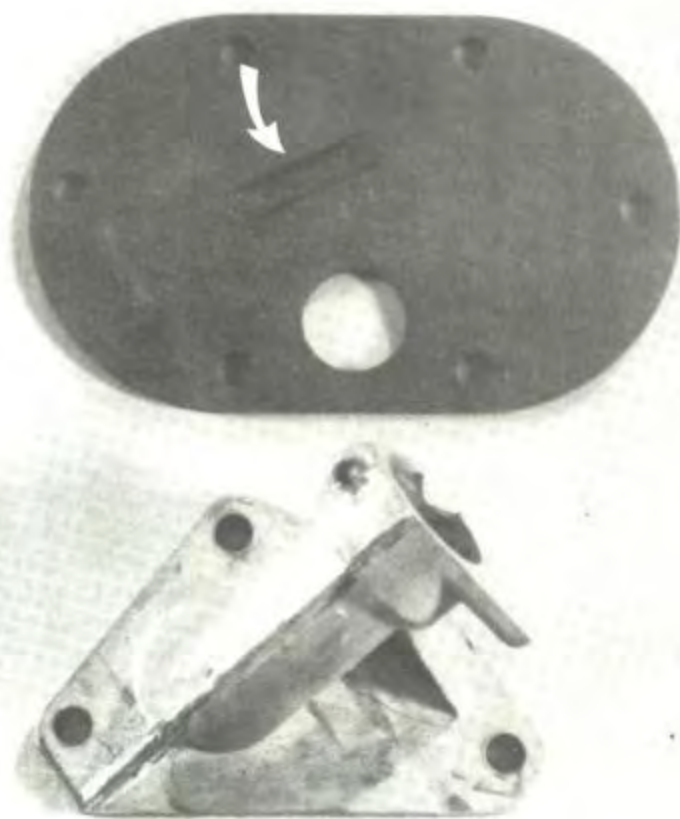
Oil pump repair kit (Buick part 1723-1393176) consists of steel cover plate and die-cast inlet. (The plate is coated with protective gunk which should be removed before the kit is put into use.)

In connection with Paul Culp's article, the Editor mentioned a later-year Buick repair kit as an alternative to machining the cover plate. This kit consists of two pieces, a steel plate which replaces the old aluminum or pot metal one and a cast piece to which the float is attached (see photo).

I acquired this kit at the Flint BCA National for about ten bucks. It is a Buick part (1723-1393176) and fits all 1936 to 1940 Buicks, plus some 1934 and 1935 series 40. According to a Buick Service Bulletin, reprinted in Vol IV, No. 1, some early '37 oil pump covers were made with five screws; the covers were changed later to six. The repair kit has six holes, but apparently all the pump bodies also had six holes, so this should be no problem. The installation of the repair kit should present no problem; however, the old screws may not be the correct length. The side of the plate shown in the photo is the inside face. The other side does not have the small groove (arrow).

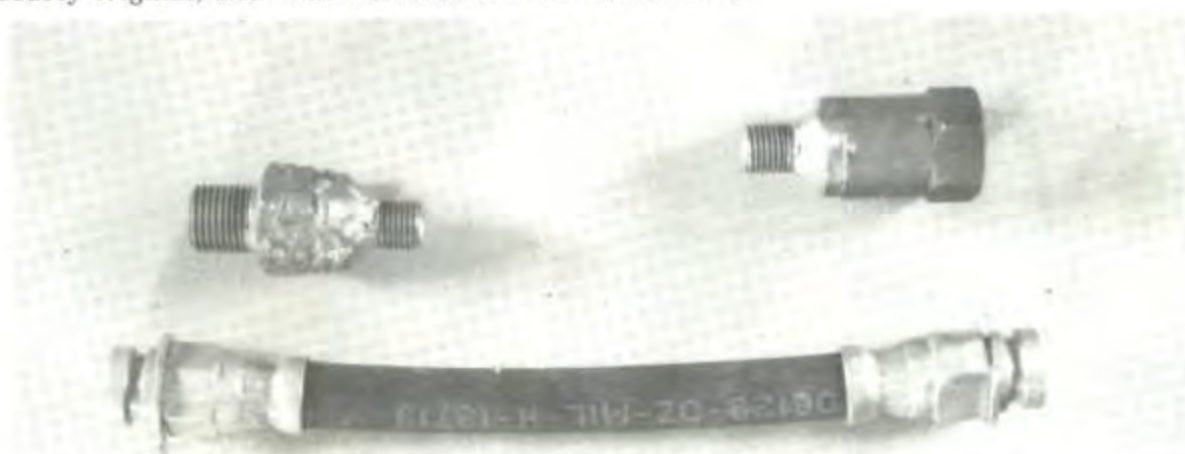
New hose made with 3/8 female fitting at each end, and original 1/2 - 20 male and female fittings with a new 3/8 male fitting brazed to each.

The front hose is the problem child. (Actually more of a problem than I realized when I started writing this). According to the article in Vol. IV, #5, this hose has 7/16" fittings and can be replaced by NAPA 36804, although it is too long. However, when I got the old hose off, I found that it had 1/2" fittings, which are apparently not readily available. This problem was solved by getting the parts store to make a new hose using the old fittings. This was done by cutting off the old fittings and brazing them to 3/8" male fittings. A new hose was then fabricated which had 3/8" female fittings and the whole thing screwed together. The photo shows this better than I can describe it. Since many auto parts stores make hydraulic and brake hoses there should be no problem getting this done.

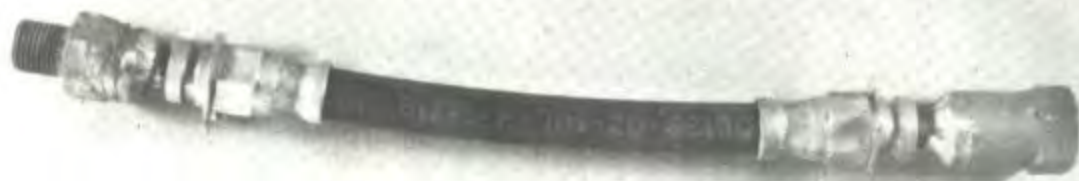
Complete "new" hose with old fittings at each end; old male fitting is chewed but useable.

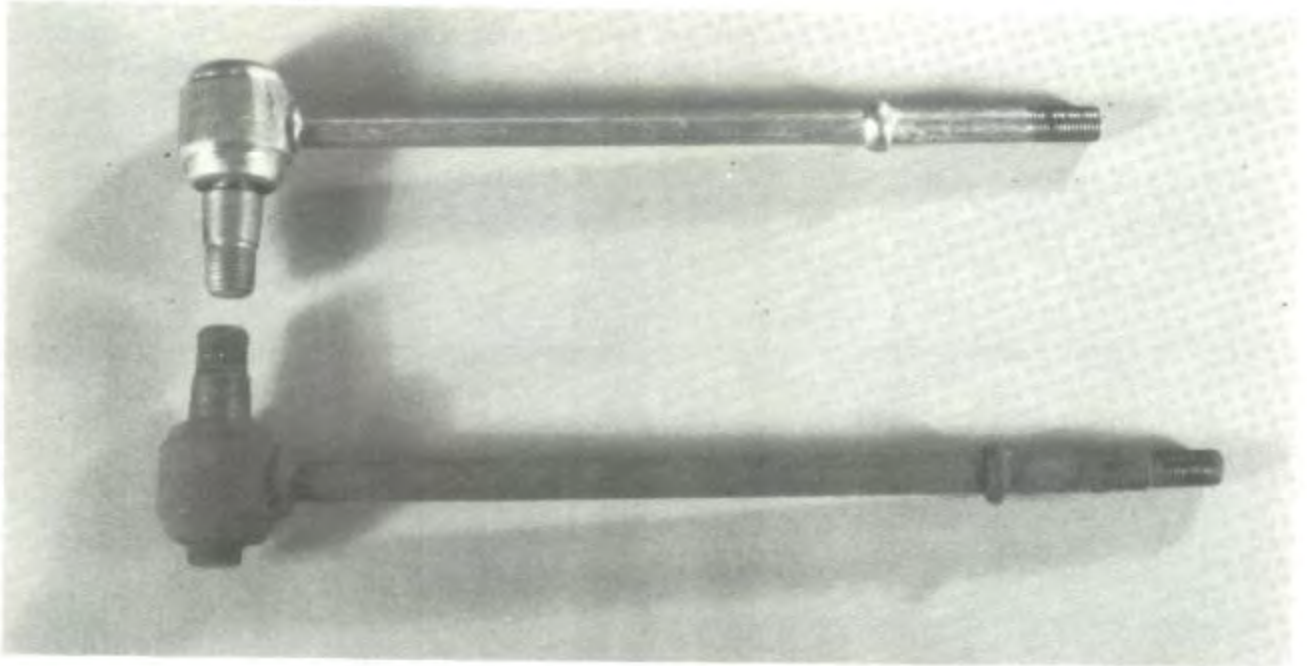
New '37 repro link and original 80-90 series link.

1937 Rear Shock Links. The second problem -- which is one I have not seen mentioned -- is rear shock links for '37 series 80 and 90. The rubber bushing at the shock absorber end of the link wears out or rots. There being no practical way of replacing the rubber without destroying the whole part, the entire link needs to be replaced. Reproduction links are available for series 40 and 60 from Dick Boyer and others, but as the photo shows these are about an inch shorter and slightly smaller in diameter than the big series part. This problem was solved by cutting the original link just above the bulge in the shaft and the new link just above the threads. The two portions were welded

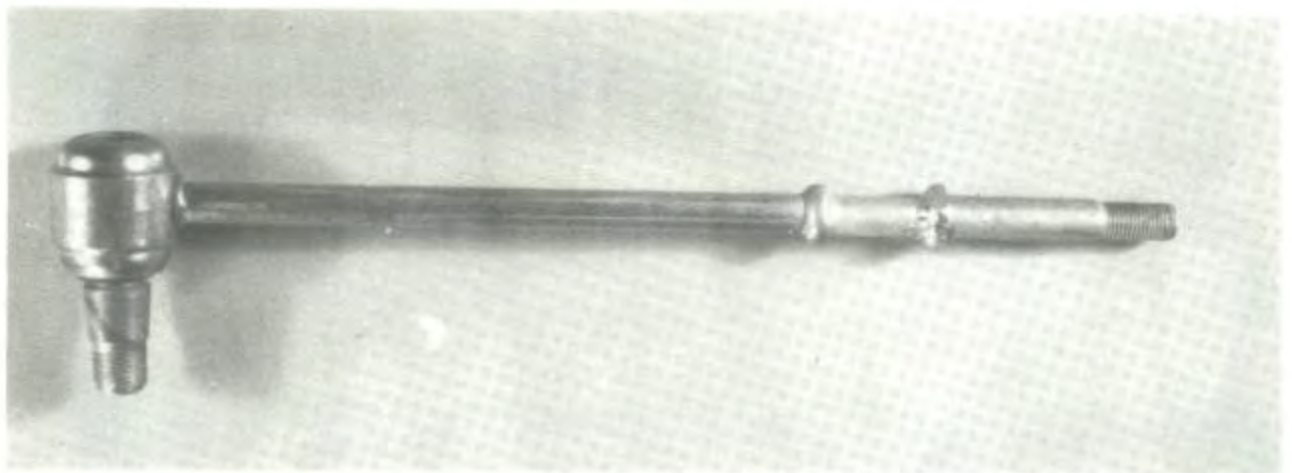
Complete new '37 80-90 series rear shock link made up from repro 40-60 series link and original part.

bulge in the shaft and the new link just above the threads. The two portions were welded together with a good heavy bead for strength. This gives a hybrid shock link with a new working end (see photo).

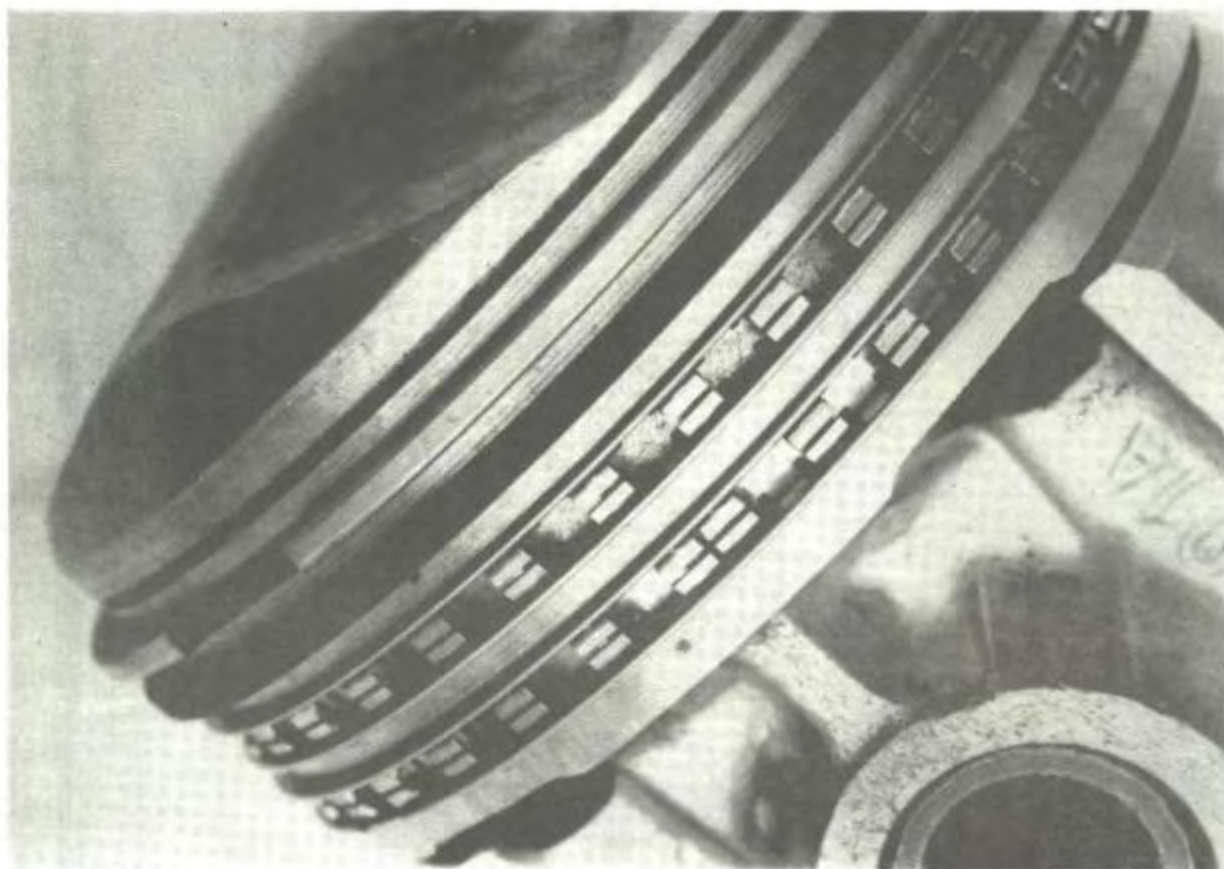
Detail view of upper piston shows ring grooves, compression and oil rings. The ring style may differ from one manufacturer to another.

Piston rings must have joints to enable them to be expanded so that they can be slipped over the piston into their grooves, and to compensate for expansion and wear. In mounting piston rings on pistons, the joints should be staggered--not placed in a vertical line, so as to prevent the compression gases from having a direct path to leak by the piston skirt.

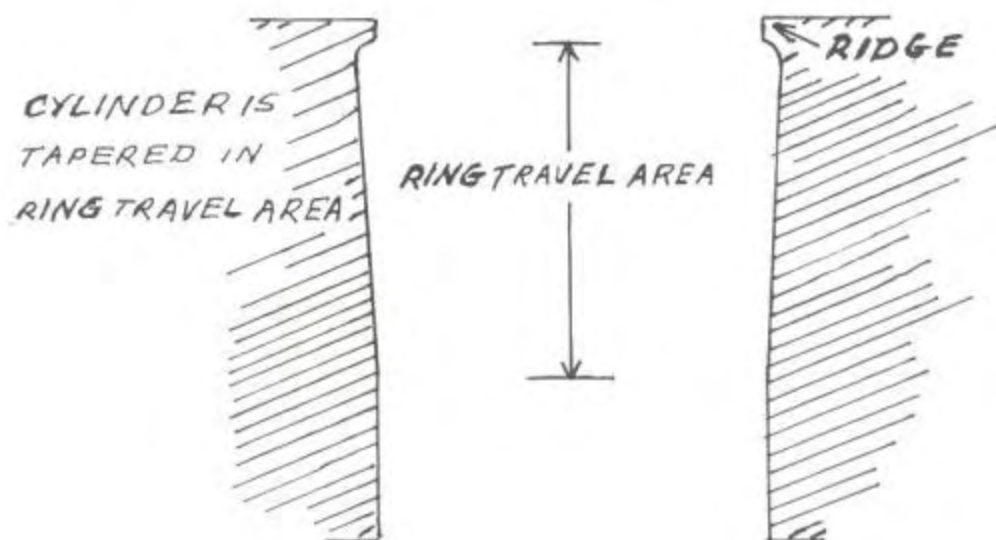
When measuring the bore, the difference between the diameter of the top of the ring travel and the diameter at the bottom is the taper. These diameters are taken at right angles to the crankshaft.

1. The original cross-hatch honing marks are still evident despite any problems in the ring travel area, (unless there is severe rust in the block.)
2. The bore diameter begins to enlarge in a taper form as we proceed up the wall. This is due to wear from the piston skirts stroking the sides.
3. The bore diameter continues to increase to its maximum dimension, just short of the top of the cylinder block. (This ring travel area receives constant friction from the rings; moreover, the act of combustion burns off any trace of lubrication.)

4. The upper compression ring wears from friction. Its manufactured sharp corner becomes rounded like the radius of an 'O' ring. This shape is reflected in the cast iron cylinder block as a round shoulder. The end of the wear area is shown in the illustration.
5. The very top area (approximately 3/32 inch) receives no wear from moving parts. This uppermost section and the lower bore are nearly identical.

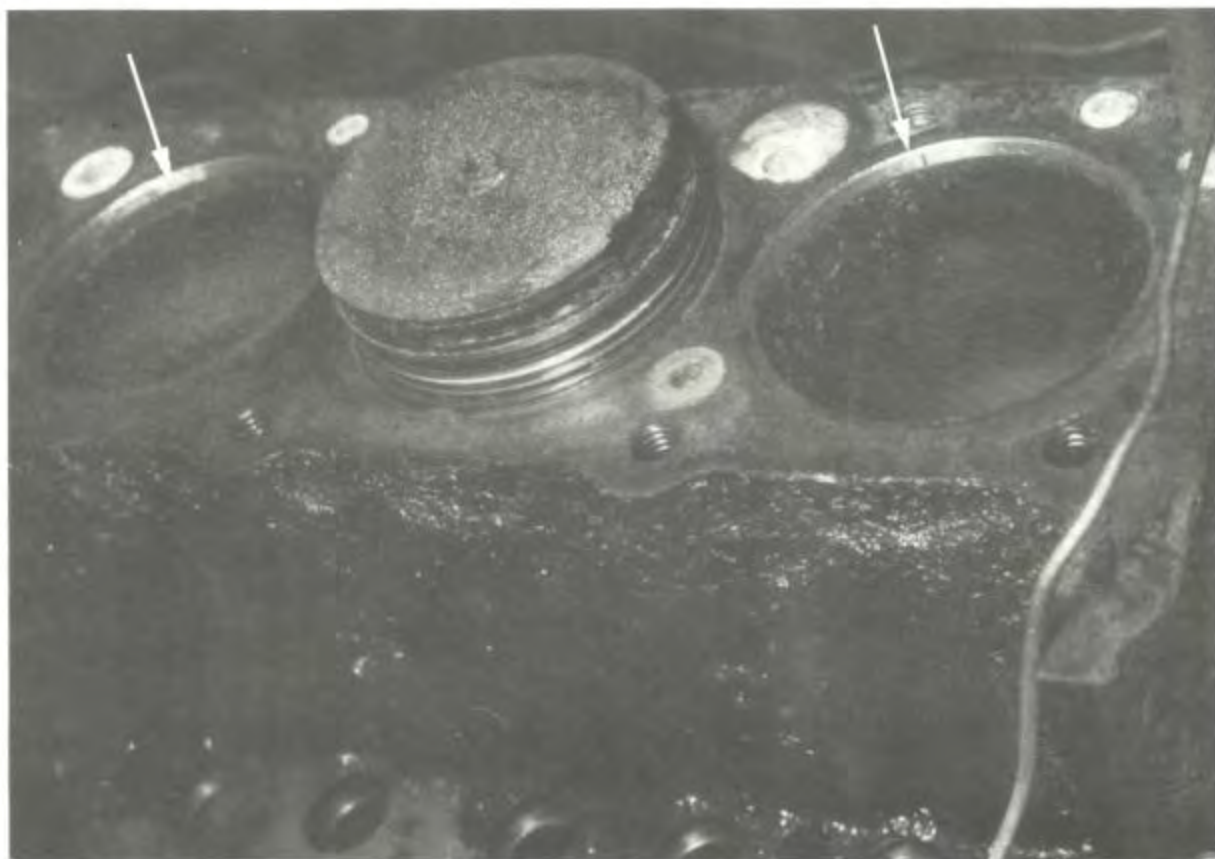
Upper cylinder bore shows area where ridge was removed (arrow).

This last portion, called the ridge, must be removed when doing a ring or piston replacement. The use of a tool called a ridge reamer is most effective. Just a note of caution: Excessive cutting with this tool into the bore will create additional problems. The ridge is removed and made flush to the uppermost ring travel area.

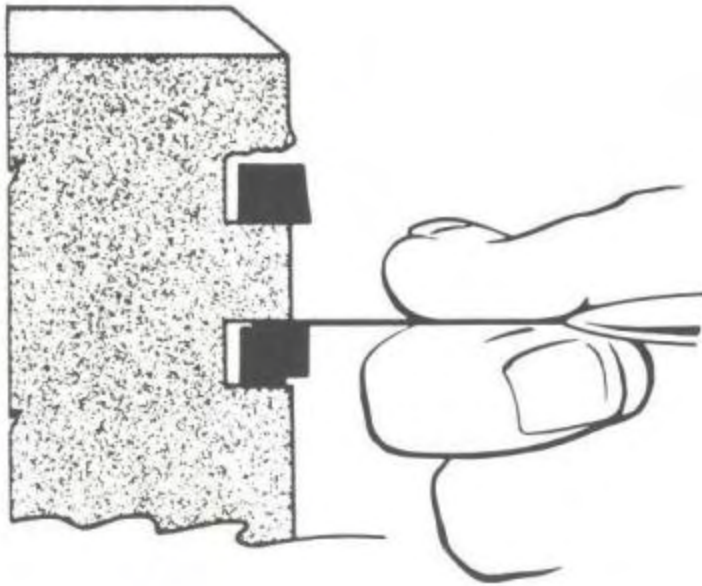
Measuring ring/piston clearance. Top wear is typical; this example indicates a need to replace the piston.

Next, the lower compression ring is mounted while staggering the gap approximately 1/3 from the previous ring position. The top compression ring is the last ring to be installed. (Note the new ring clearance in an old piston: if more than .0015 inch, then the piston should be replaced.)

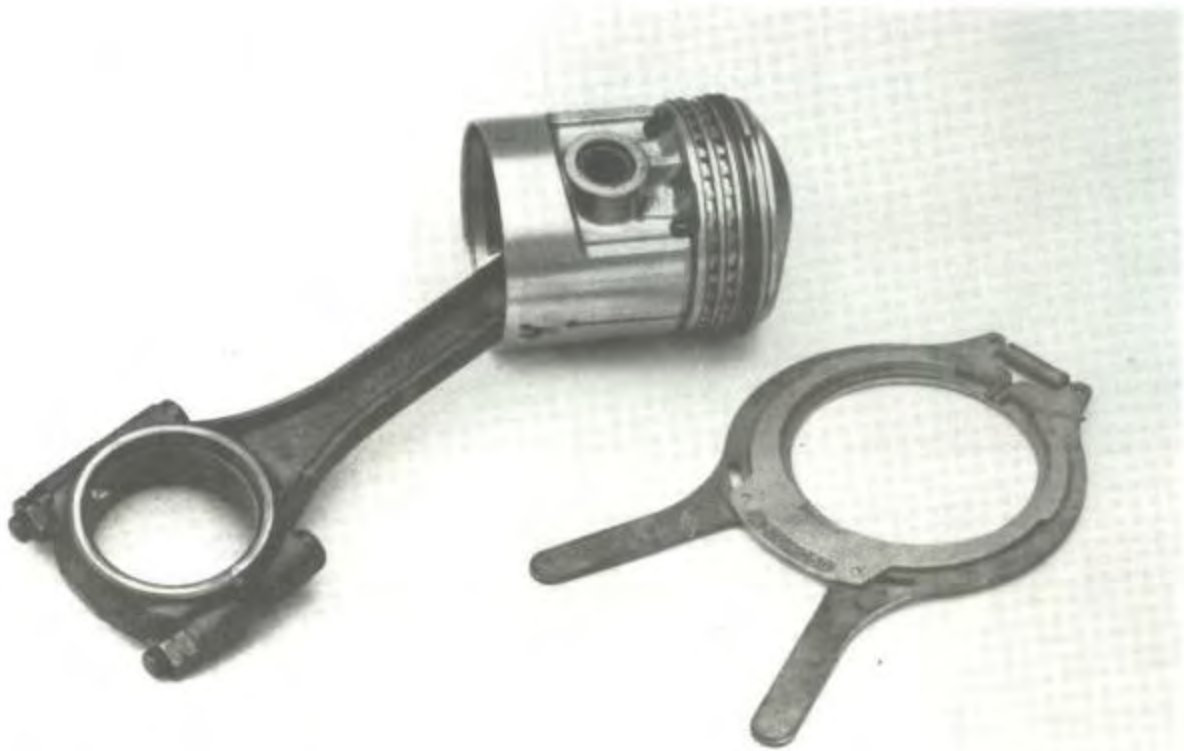
Connecting rod with insert bearing; new piston and rings; ring installing tool.

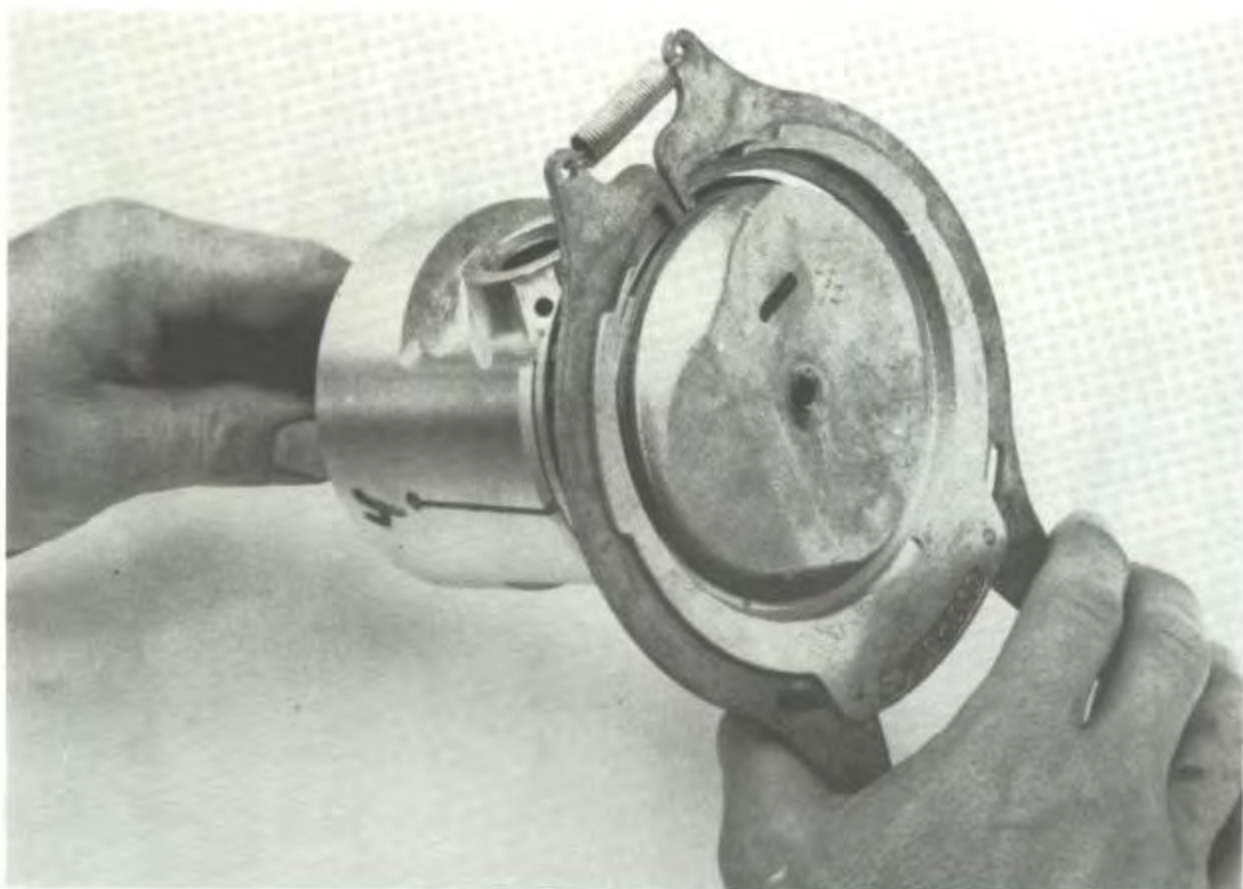
Installing rings using ring expanding tool. ("Universal" ring tools work as well and are much cheaper than the one pictured.)

Connecting rod and piston was assembled and mounted in a bench vise. First, the lower oil control ring was installed, then the second control ring. Installation tools are available either by specific diameter or a universal type.

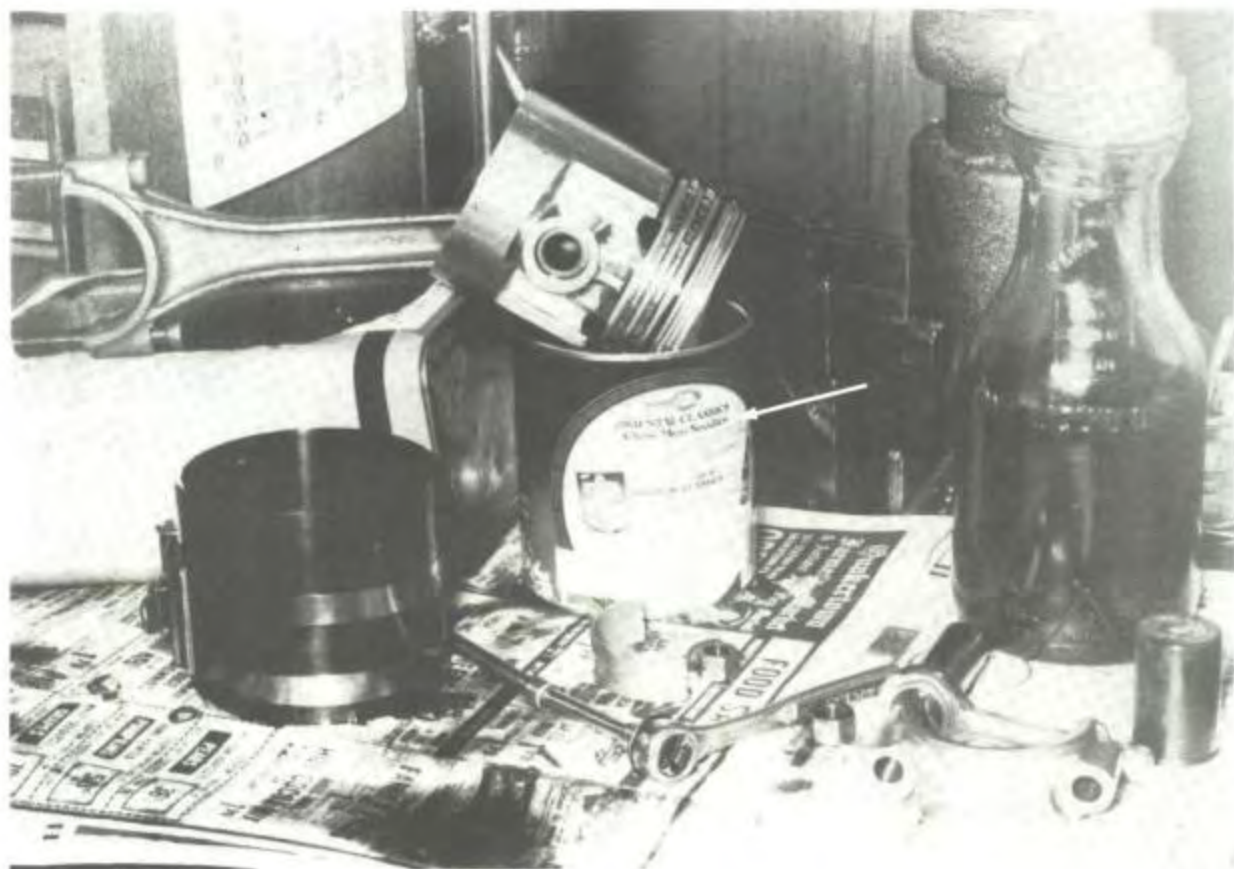
Preparing for piston installation: engine oil; ring compressor; wrenches. (Note this also gives some indication of what author Culp eats.)

Placing the integral unit of ring compressor, piston and connecting rod into the bore, the piston is forced through the sleeve of the ring compressor into the cylinder bore. The use of a large hardwood dowel about eight inches long, between the piston head and hammer, serves as a spacer to tap the piston into the bore. Note that the rings will cause four moments of hesitation as one by one they conform to the actual cylinder block bore. (If excessive hammering becomes necessary, then completely remove piston and compressor, lubricate and repeat, following the above steps.)

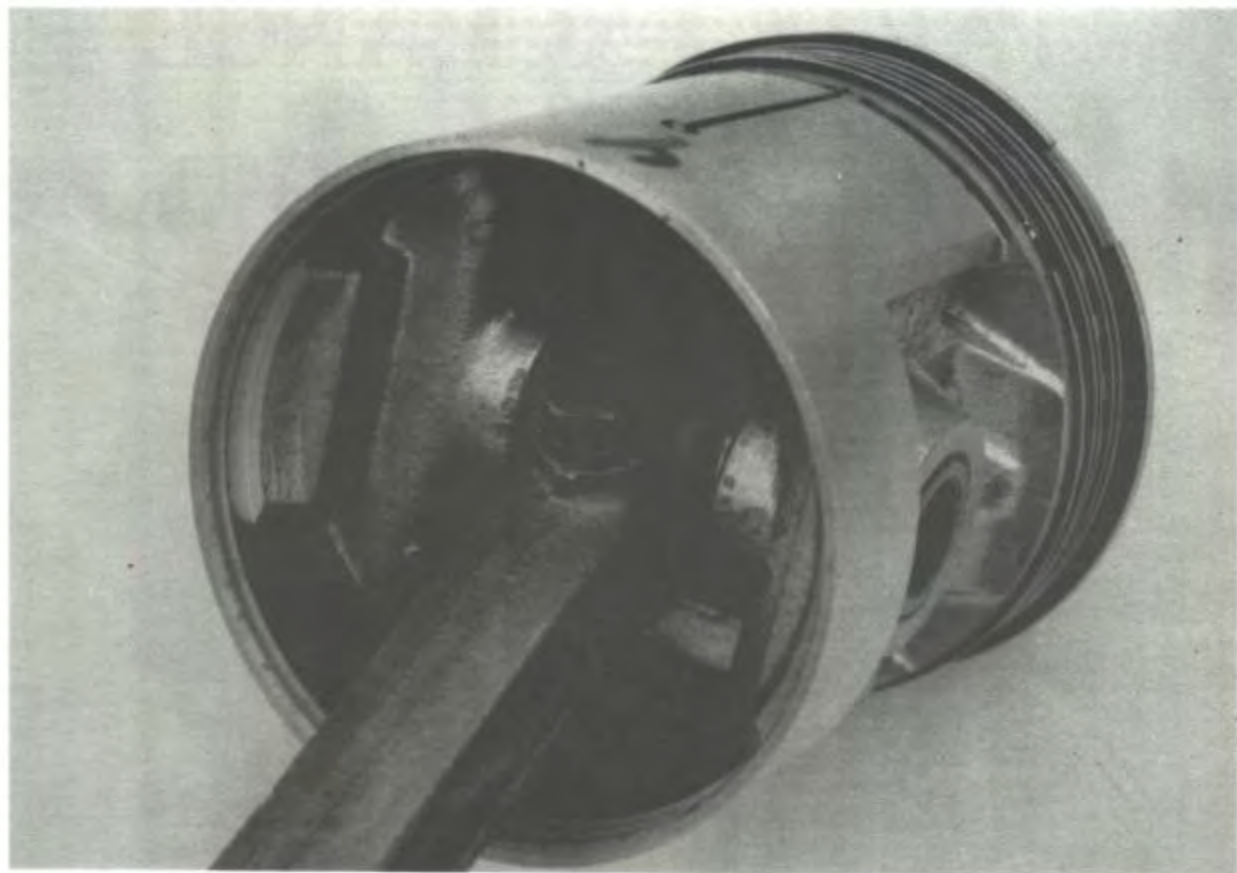
Connecting rod installed in piston.
